Chambon Dam Reinforcement Works

Olivier Chulliat¹, Etienne Grimal², Emmanuel Robbe³

1, 2, 3 – EDF – Hydro Engineering Center – Savoie Technolac – 73373 Le Bourget du Lac – France

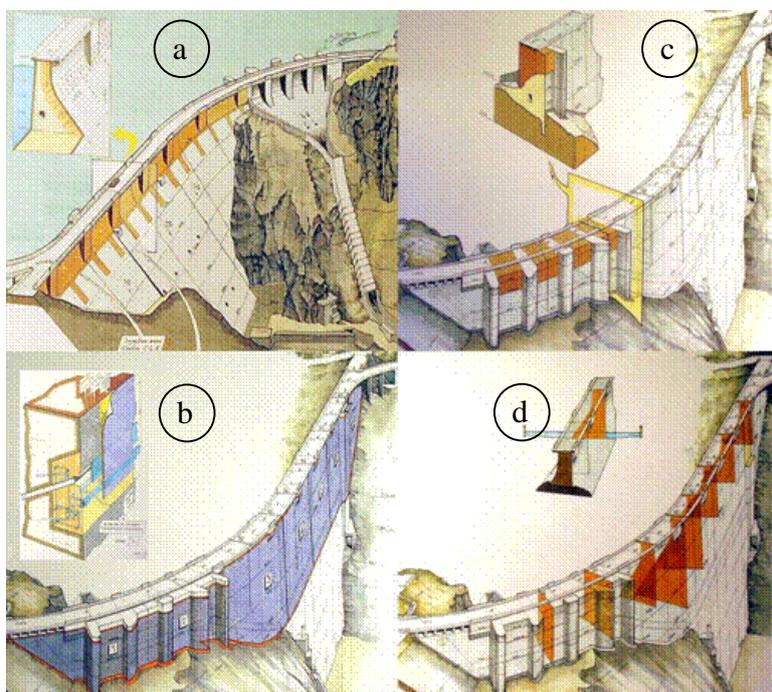
Before cutting, the significant open lift joints spotted in the upper part of the downstream face (5 to 20 m below the crest, 2 to 3 m deep over a 200 m length) were grouted (Figure 1 – a). This process was necessary to

Figure 1. 1990's main works in relation with AAR
a: crack grouting, b: upstream sealing, c: old spillway concrete, d: slot cuts

From 1991 to 1997, 9000 m² of Carpi PVC sealing geomembrane were installed on the top 40 m of the upstream face in order to remove the uplift in the upper part of the dam, due to cracks opening, and to solve the question of the slot watertightness (Figure 1 – b). The upstream face was smoothed with sprayed mortar in advance. A reinforced beam was concreted at the base of the geomembrane. The drainage and puncture protection was ensured by a geogrid. The geomembrane was tightened between vertical profiles 1.85 m apart. The drainage system was divided into 9 isolated compartments with their own leakage monitoring. In such manner the localization of the entry point of any leak was facilitated. Thanks to the complementary foundation grouting works and the concrete shell added at the spillway toe, the left abutment leakage dropped from 50 l/min in 1994 to 22 l/min in 1995 and up to 17 l/min in 1997.

Before starting the slot-cutting works, the initial spillway was decommissioned. The gates were removed and the openings were filled with 4,000 m³ of concrete (Figure 1 – c).

Three campaigns of slot-cutting were required from 1995 to 1997: 2 slots in 1995, 3 in 1996 and 3 in 1997 were completed with 11 mm diamond wire from 18 to 32 m in depth below the crest (Figure 1 – d). The main effects of slot cuts on the dam were: 1) the return of the curved part toward downstream, and 2) the return of the bank side blocks toward the center of the dam. During the last campaign, the 3 slots did not close and surrounding slots and joints opened, this was the sign of the effectiveness of the stress relief.

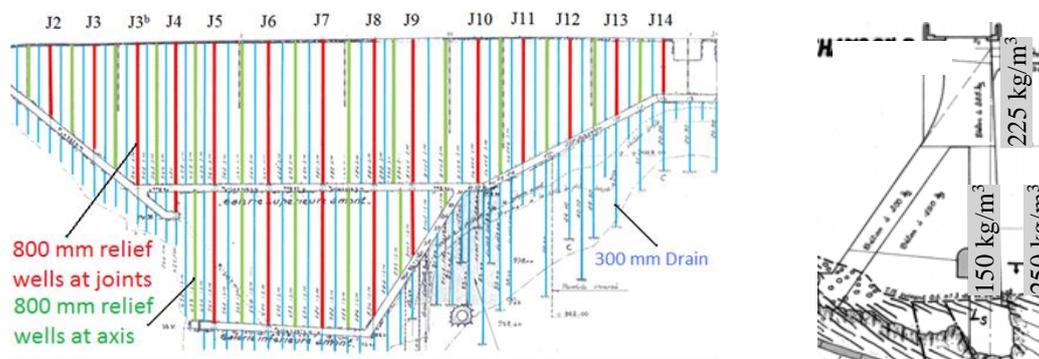
This extensive campaign showed the almost systematic presence of a vertical cracking along the elevation drainage curtain in the upper part of the dam, which led to the conclusion that it was not possible to exclude some upstream concrete blocks instability in earthquake conditions. They might be pre-cut by the elevation drainage curtain and extended horizontal or vertical discontinuities. The presence of these cracks was then explained by several factors: (i) vertical drains of diameter 800 mm (in red and green on Figure 2) and 300 mm (in blue on Figure 2) are separated by an average distance of 3.20 m; they could work as a “precut line” along the axis of the dam, (ii) the differential expansion rate between the upstream concrete containing 250 kg/m³ of cement and the downstream one containing 150 kg/m³ could create shear stresses along the same surface (Figure 2), (iii) the geometry of the dam, curved in its left bank side. Most of these cracks are observed in drilling holes through the curved zone and are several millimeters to more than 1 centimeter open. As the different cracks are most of time not linked inside the dam body, the presence of a continuous upstream slab can likely be excluded, but potentially unstable blocks under earthquake loading may exist. These virtual blocks are delimited: in the vertical longitudinal direction by the vertical longitudinal cracking and the upstream face (2.50 to 4.10 m), in the vertical transversal direction by dilatation joints and saw cuts (5.30 to 16.30 m) and by cracks potentially linking existing drains (singular points with an average distance of about 3 m) and in the horizontal direction by the construction joints (2.40 to 2.90 m).

Figure 2. The vertical drainage curtain seen from downstream and cross section

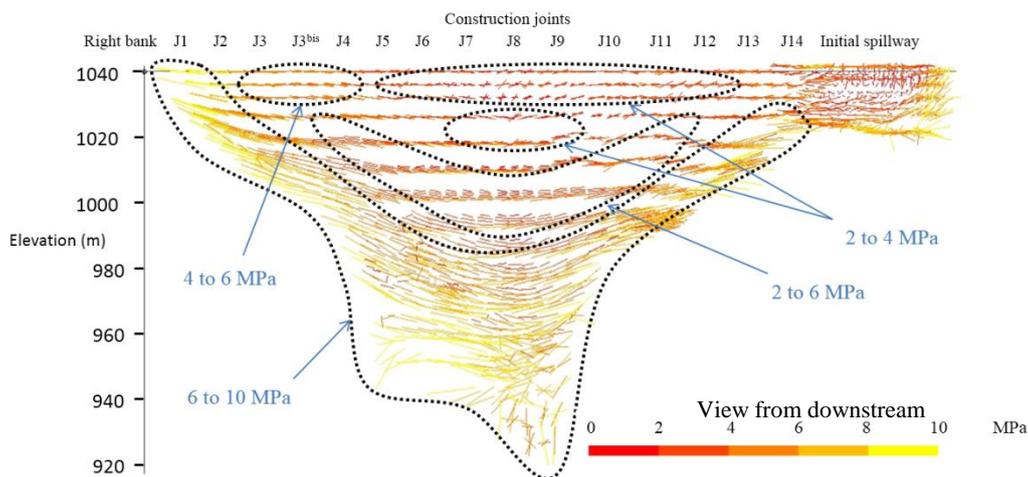
They nevertheless displayed noticeable stresses parallel to the abutments, with the risk of shearing the rock/dam interface in a medium term (Figure 5).

Figure 5. The maximal principal compressive stresses calculated in the dam

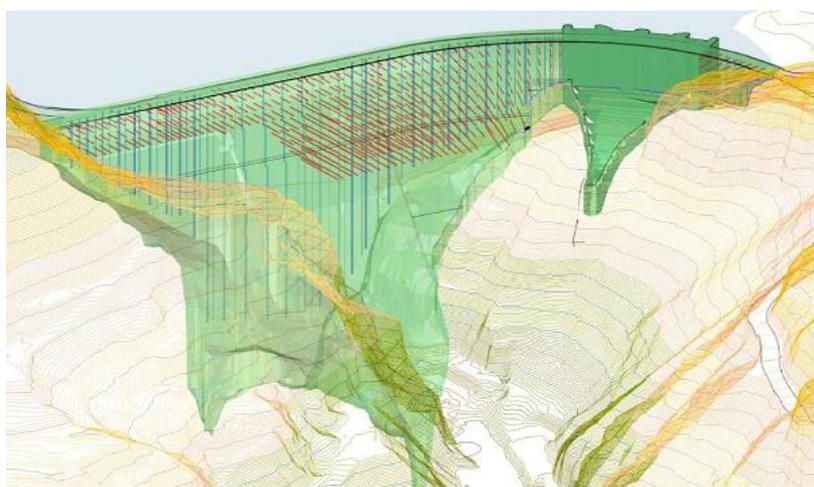
Figure 6. The tendons pattern (red) and drainage curtain (blue) seen from downstream

The main objectives of the second campaign were to reinforce the integrity of the upper part of the dam and to prevent any upstream block from falling that could lead to destabilization of the dam. The upper part confinement was obtained by the installation of 415 tendons (Figure 6).

Consisting of horizontal cables, with greased sheathed strands type T15, crossing the structure from upstream to downstream, they were pre-tensioned and non-grouted on the outer side of the general sheath, as the successful completion of the work could be impaired due to the presence of cracks. They are 3.70 m (horizontal) and 4 m (vertical) spaced, with about one tendon for 15 m². The obtained mesh fits the most likely size of the blocks, delimited by vertical cracks parallel to the axis and the upstream face, vertical joints or former slot cuts parallel to the stream direction and the lift joints in the horizontal direction. Upstream and downstream cable heads are fully embedded in reservations drilled in the dam, with diameter ranging between 500 and 700 mm. The corrosion protection is enhanced on the upstream side by concreting the reservations and by the presence of the sealing membrane. As progressive tension increase due to concrete expansion remains possible, the downstream cable heads were designed to be adjustable and detensioning operations could be necessary in order to fit the required tension.

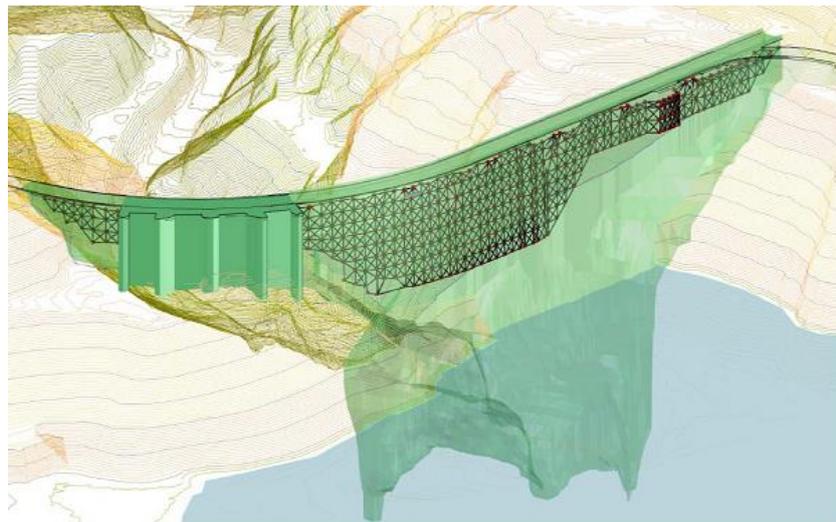
Figure 7. The carbon fiber net seen from upstream

In addition to tendons, a carbon fiber composite net has been set up on the upstream face. It consisted in the sticking of 6,000 m carbon fiberstrips. The 20 to 30 cm wide strips link the tendon heads, along vertical, horizontal and diagonal lines (Figure 7).

The carbon fiber net serves confinement of small blocks that could escape the tendons action. Strips composite material (carbon strips glued with epoxy resin), composed of 1 to 8 layers glued to the surface previously sand blasted, were designed to form a “chainstitch” and to resist tensile stress due to earthquake and further swelling. An anchoring device, designed after laboratory tests and inserted into the upstream reservation, allows the connection between the carbon fiber strips and the tendon upstream heads (Figure 8). It is composed of an upstream plate maintaining the bands and a downstream plate transmitting the efforts to the tendon head, linked by eight rods (type M24 to M40 according to the efforts to be transmitted). Bands are continuous in current zone and re-curved over the anchoring devices located on the periphery of the reinforced zone.

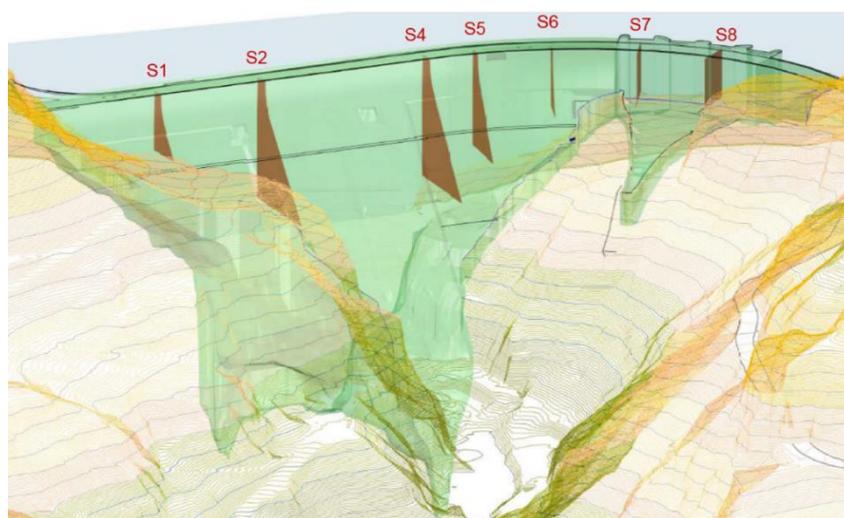
Figure 9. The design of the new campaign of slot cutting

The new campaign by diamond wire sawing was defined using the numerical model (i) to avoid the re-compression of the upper part of the structure and (ii) to decompress the stress paths parallel to the abutments (Figure 9).

Slot cuts mostly followed the same tracks than in the 1990's, with the following exceptions:

- slot cut S3 in the central part of the dam was not sawn again, due the presence of a cable stuck during the previous campaign,

- both slot cuts flanking S3 (S2 and S4) were deepened to 42 m, leading to an area of 650 m² each, in order to compensate the non-resawing of S3, but mainly to increase the stress reduction efficiency along the concrete/rock interface,
