# Quantifying Seepage Flow Velocities in Embankment Dams from Optical Fibre Distributed Temperature Measurements

## 2. CANAL EMBANKMENT DESCRIPTION

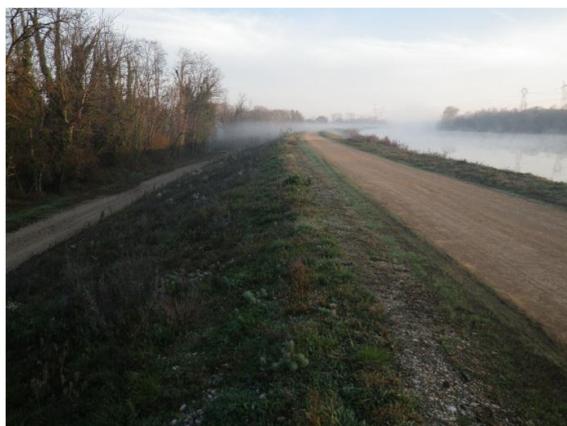
**Figure 1: View of the canal embankment**

The 15-km long canal embankment of interest is located on the right bank of the intake channel of an EDF's hydraulic power plant located in the South-East of France. Figure 1 shows a view of this canal from the top of the embankment.

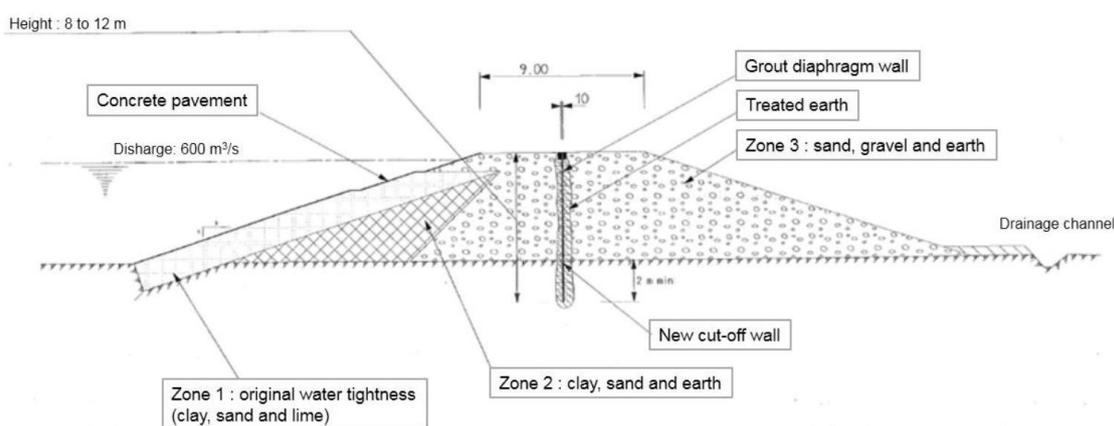
**Figure 2: Cross section of the canal embankment before its rehabilitation 3**

The embankment's height above natural ground varies until 15m. Dam crest is 9m wide, downstream and upstream slopes are 3H/1V. The foundation is made of silty sandy alluviums. The embankment body includes a watertight upstream fill made of clay, sand and lime. The central and downstream part of the embankment body are made of sandy gravels. In some parts of the embankment, diaphragm walls have been realized from the crest to the upper part of the foundation (Fig. 2). However, this canal embankment which was originally built in the years 1890' has suffered for decades of seepages and low kinetics types of internal erosion (suffusion and contact erosion).

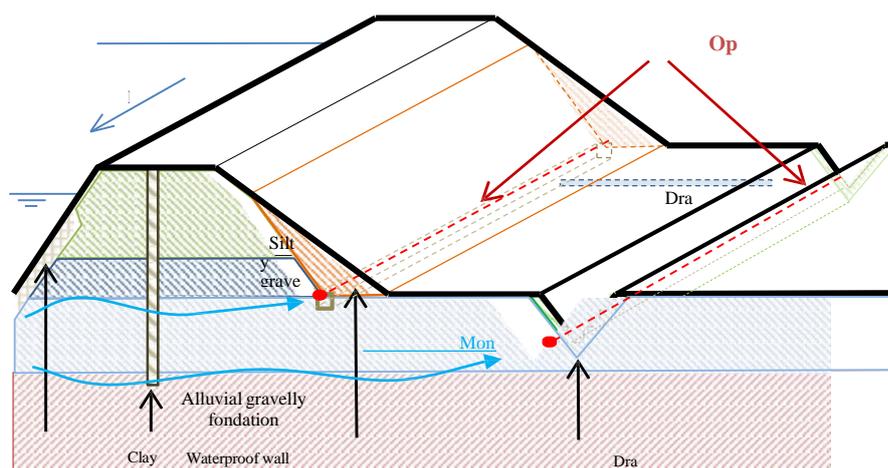
**Figure 3: 3D view of the canal embankment after its rehabilitation**

As this canal embankment is located in a high-density urban area where a breach due to internal erosion is a major safety issue, rehabilitation works have been carried out in 2014, following a safety assessment study. These works included the realization of a continuous diaphragm wall from the embankment crest to the upper part of the foundation and the rehabilitation of the drainage at the downstream toe of the embankment. The rehabilitation of the drainage included the recalibration and reinforcement of the existing drainage channel in addition to the realization of a new drainage ditch at the downstream toe of the embankment, in order to improve the resistance of the embankment against internal erosion and to enhance seepage monitoring. Taking advantage of the undergoing construction, optical cables were installed during the works of the new drainage ditch and the existing drainage channel (Fig. 3). The goal of this fiber optic monitoring system is to monitor the spatial distribution of seepages and to quantify the seepage flow velocities.

In this section of the embankment, the core is composed of different gravelly and silty-sand soils. A 1-meter-tall layer of silty-sand supports the core. The foundations are composed of sandy-silty-gravel (see Fig. 3).

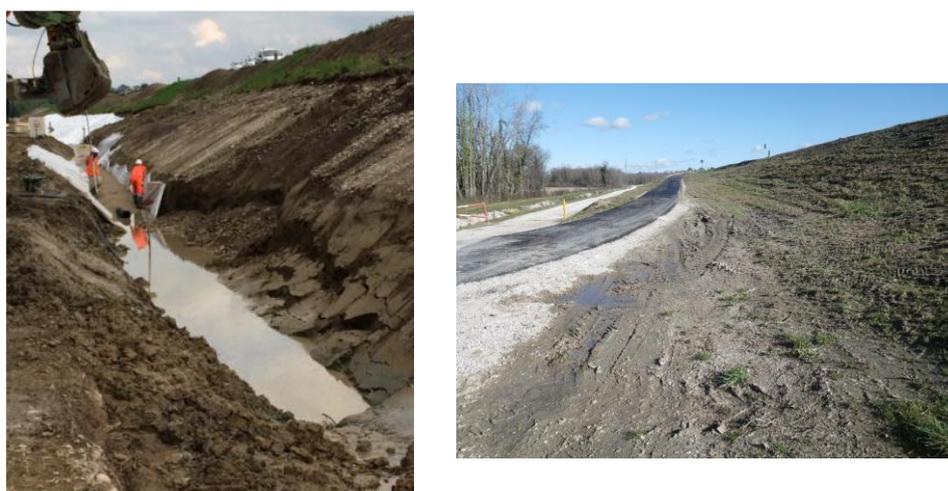
**Figure 4: Picture of the draining ditch being excavated during works in 2014 (left picture), observation of humid soil (right picture).**

First of all, during the optical fiber installation works in 2014, a 600-meter long area of saturated soil with the presence of very slight seepages has been highlighted during excavation of the draining ditch between locations KP (Kilometric Point) 9.5 and KP 10.1. Figure 3 is a picture of the draining ditch being excavated. A high water table level was also identified during drainage channel works in this area.

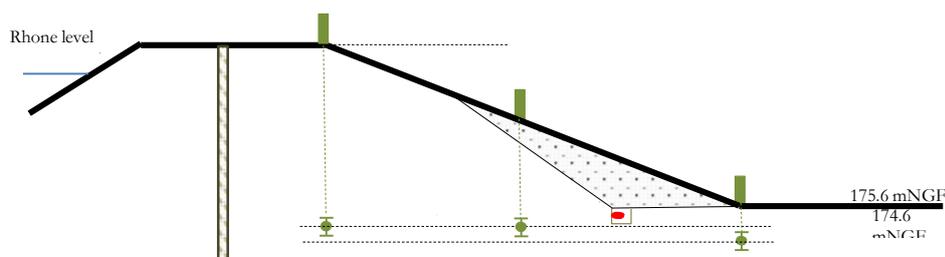
**Figure 5: Piezo metric profile at KP 9.670. mNGF unit refers to the topographic level in the French national reference.**

The piezometers along the embankment, during the period from 2014 to 2015, are extremely stable in the area of interest and further with a standard deviation of about 20 cm. Figure 5 shows a piezo metric profile at location KP 9.670 compiled with a 2-year dataset. Maximum, minimum and average piezo metric levels are displayed in the French national reference unit. 5

At location KP 9.670, the piezo metric profile shows that the optical fiber is located around 30 cm above the highest water line. At location KP 9.940, the water level is slightly above the level of the optical fiber, submerging it.

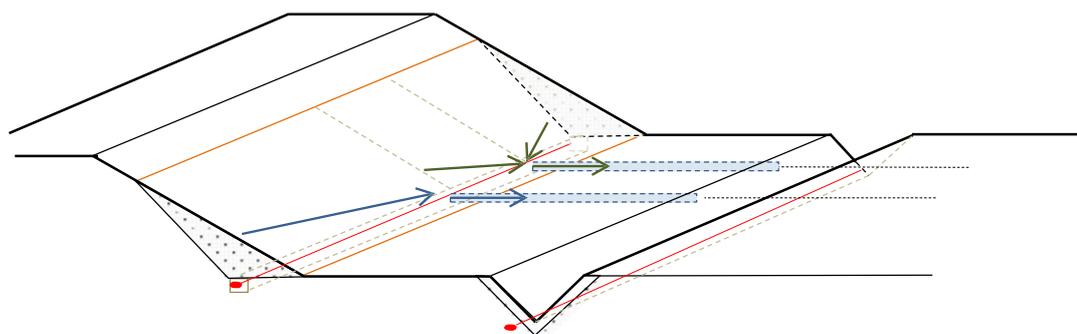
**Figure 6: 3D view of the drainage slopes and outlets layout**

The draining ditch is composed of two drainage sub-sections as shown in Figure 6. The first sub-section drains the draining ditch from location KP 9.46 to 9.7 with an outlet located at KP 9.58. The average water discharge over the years 2015 and 2016 was 220 L.min<sup>-1</sup> with a maximum up to 400 L.min<sup>-1</sup>. The second sub-section spans from KP 9.7 to KP 10.1 with a non-monitored outlet located at KP 9.7. The visual inspection of March 2017 gave an estimated discharge of about 100 L.min<sup>-1</sup>.

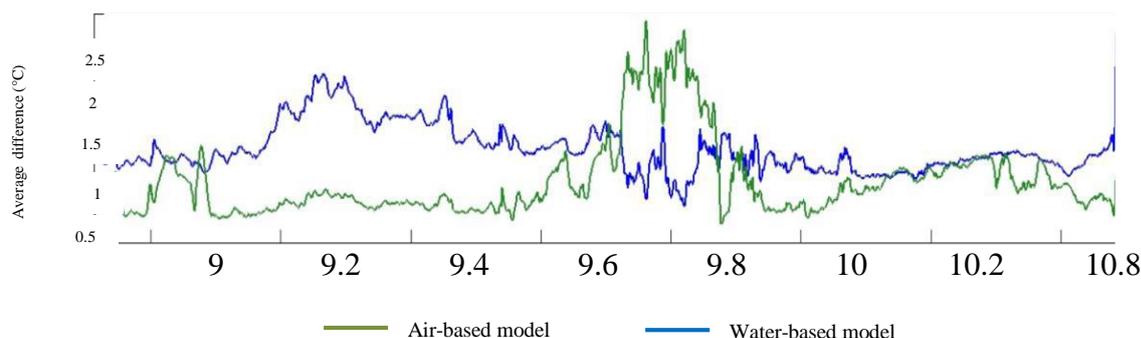
**Figure 7: Temperature difference between the water-based model and the optic fiber temperature (blue line) and between the air-based model and the optic fiber data (green line)**

These two temperature numerical models are compared together in terms of their performance to reproduce the measured optical fiber temperatures. When the air-based model gets less convincing, and the water-based model becomes better, a seepage flow from the canal is likely to exist. Figure 7 presents the example of a post-processing graph.

This graph shows the average temperature difference between numerical results and measured temperatures, along the position of the optical fiber cable. Between KP 9.7 and 9.9, the average temperature difference between water-based model and measured temperature drops whereas the air-based model tends to divert from the measured temperature. This area is highlighted as a potential area of seepage. Between KP 9.7 and KP 9.9, the water-based model fits the measured temperature with a seepage flow velocity of about  $5.10^{-5} \text{ m.s}^{-1}$  over a span of about 150 meters. Figure 8 shows the time evolution of the water-based model at PK 9.797 at the center of the area highlighted.

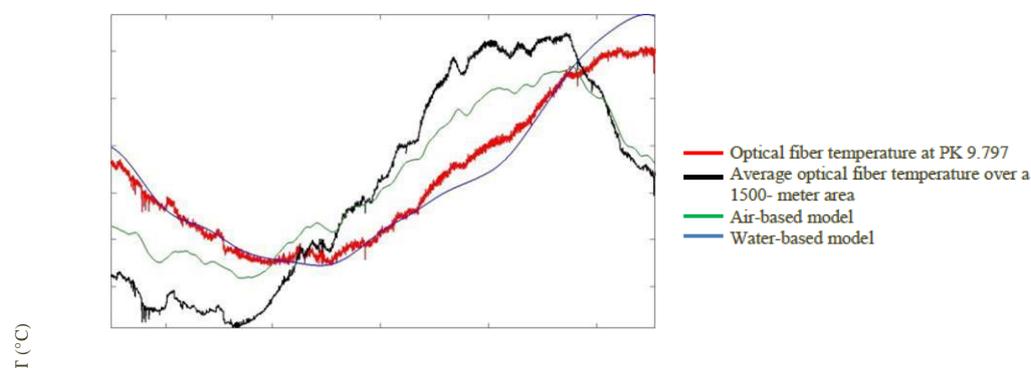
**Figure 8: Air-based and water-based model temperature evolutions at PK 9.797 compared to optical fiber temperature evolution.**

The seepage flow rate can be estimated from the width of the detected leaking area, from the estimation of the flow velocity and assuming a height of the seepage path in the dyke. If a 0.2 to 2-meter average height is assumed for the seepage, a total flow rate between  $100 \text{ L.min}^{-1}$  and  $900 \text{ L.min}^{-1}$  is calculated. This result is consistent with the estimated water discharge at the outlet 1 ( $100 \text{ L.min}^{-1}$ ). The monitoring of the water discharge at the outlet 1 would give better confidence in this comparison.
