# Rehabilitation of the Sylvenstein Dam, Germany Success Proof by Major Flood 2013

**Peter Banzhaf**

**BAUER Spezialtiefbau GmbH, Bauer-Street 1, 86529 Schrobenhausen, Germany**

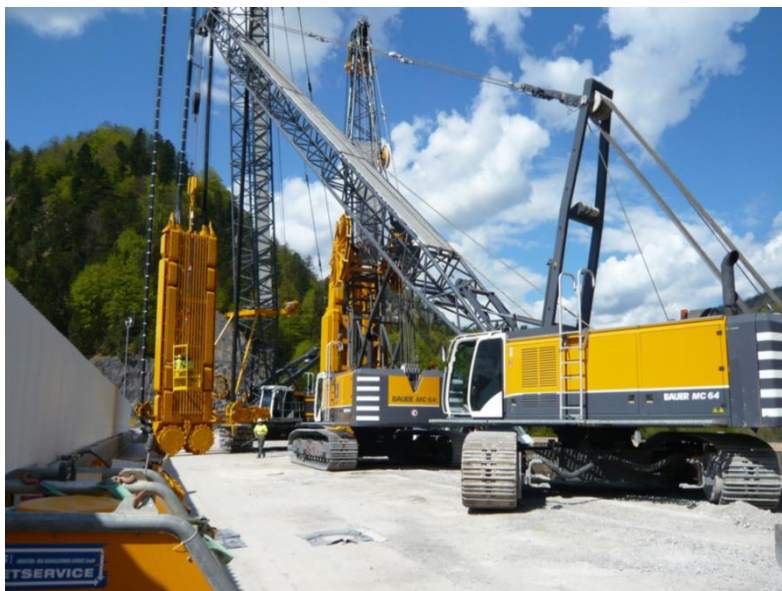
**Figure 3. Cut-off wall equipment on a limited working platform**

For the Sylvenstein dam, on a limited working space, a hydraulic grab and the specially modified hydraulic cutter was chosen to install the wall to the satisfaction of the client, both in time and budget. The required slurry handling plant – consisting of mixing, storage and desanding units – had to be installed along the road to the dam crest. The concrete batching plant was placed downstream of the dam.

Pre-excavation with a grab is the method typically used for economic excavation of the panel elements in soil where depths usually do not exceed 40 m. The hydro-cutter technology is the established and tested method for cutting into rock and through boulders, ensuring a defined overlap between the individual panels for a continuous wall and for installing deep vertical panel elements.

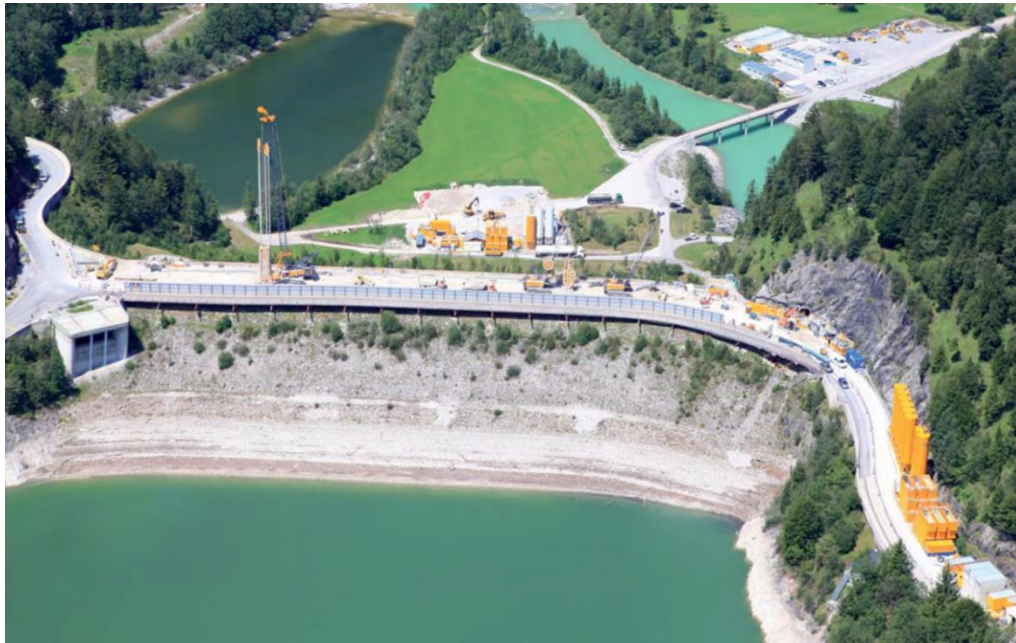
**Figure 4. Cut-off wall installations with diaphragm wall grab, cutter and plants**

The diaphragm wall executed at the Sylvenstein Dam had to reach a maximum depth of approximately 70 m below the dam crest as there are alternating layers of gravel and rock sediments and the highly varying permeability of the old underground sealing. Preparation works were executed with a grab in the upper part of the trench. Then, the diaphragm wall was installed, deploying a Bauer BC 40 Trench Cutter with a Bauer MC 128 base carrier. The wall is laterally embedded in very hard dolomitic limestone.

The location and natural surroundings of the project site were a challenge to logistics. As working space was limited on the dam crest the concrete mixing plant was assembled in the valley below the dam and the plastic concrete was pumped up 50 m to the work platform.
