Monitoring Timber Structures with Fiber Optics Sensors: State of the Art and Application to a Timber Beam

ABSTRACT: Fiber optic sensors (FOS) offer compelling advantages for Structural Health Monitoring (SHM). However, their application in timber structures remains underexplored. This article reviews the state-of-the-art use of FOS in timber structures and presents an experimental study conducted at the Universitat Politècnica de València. A 3-meter-span timber beam was subjected to a four-point bending test and instrumented with long-gauge strain FOS. The measured strains were used to derive stresses, which were then compared to theoretical values. The results highlight the potential of FOS for accurate stress monitoring in timber elements and contribute valuable insights to the advancement of SHM in sustainable construction.

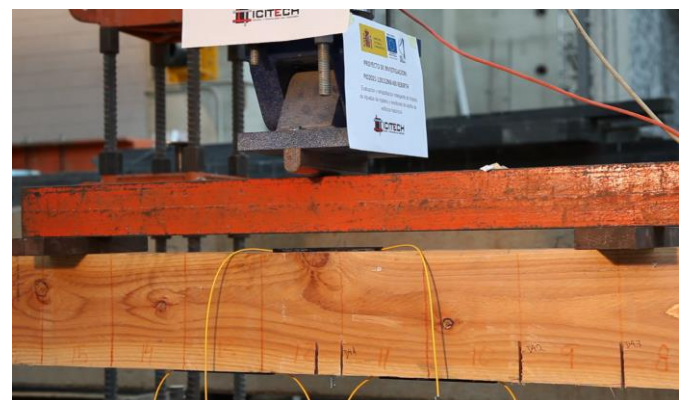
Figure 4. Central segment of the tested beam showing the loading elements.

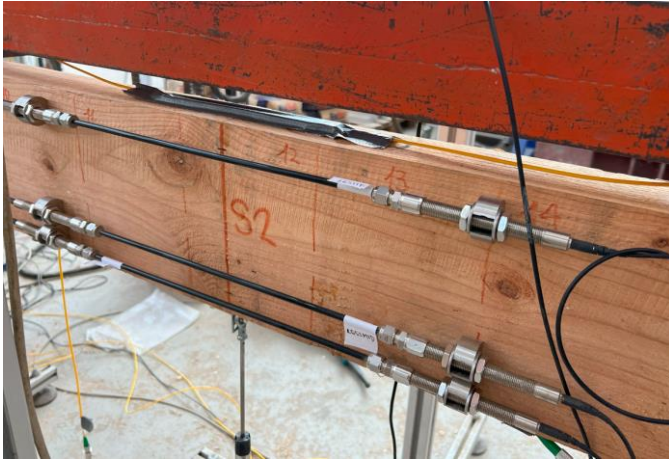
Figure 5. FOS installed in Section S2.

The beam's vertical displacements were recorded using two linear variable differential transducers (LVDTs). Additionally, five long-gauge strain sensors were installed on the beam using brackets screwed into the timber. Table 1 provides the detailed positions of these sensors. The gauge length of the FOS was 500 mm. Figure 3 shows the position of the sensors installed for the test, both LVDTs and FOS. Figure 4 shows a detail of the elements used to distribute the load to the beam, while Figure 5 and Figure 6 provide a detailed view of the long-gauge sensors installed at sections S1 and S2.

Sensor ID	Measuring units	Related section	Position
LVDT-S2	mm	S2	Mid-span
LVDT-S1	mm	S1	1 m from mid-span
LGS2TF	microstrains	S2	27.88 mm from the beam's top face
LGS2BF	microstrains	S2	26.58 mm from the beam's bottom face
LGS2MID	microstrains	S2	57.54 mm from the beam's bottom face
LGS1TF	microstrains	S1	30.48 mm from the beam's top face
LGS1BF	microstrains	S1	30.05 mm from the beam's bottom face

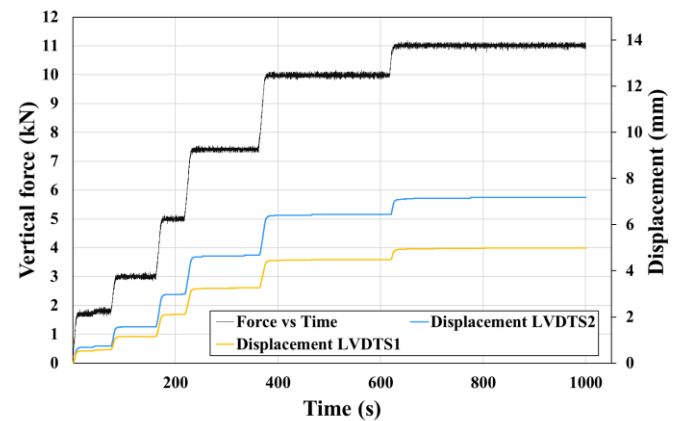
Figure 7 displays the force applied by the hydraulic jack over time, along with the displacements recorded by the LVDTs, plotted on a secondary vertical axis. The curves follow the same trend, showing that the displacements increase proportionally with the applied force. The number of steps in the displacement curves corresponds exactly to the loading steps of the applied force. The maximum recorded force was 11.19 kN, which resulted in LVDT displacements of 7.18 mm at Section S2

(LVDTs2) and 4.99 mm at Section S1 (LVDTs1).

Figure 7. Force and LVDT displacements over time during the bending test.

- $F_2 = 10990$ N,
- $F_1 = 3200$ N,
- $w_2 = 7.14$ mm,
- $w_1 = 1.66$ mm,

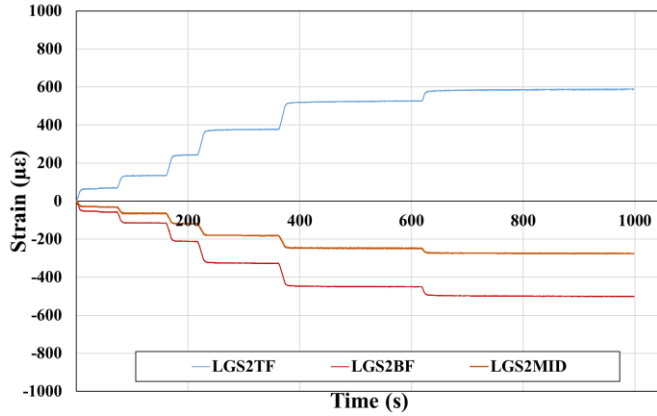
Figure 8 and Figure 9 display the strain curves recorded by each long-gauge sensor throughout the test. Sensors installed below the geometric centroid of the beam cross section are expected to record tensile strains (negative values), while those positioned above the geometric centroid should register compressive strains (positive values). As expected, sensors LGS1TF and LGS2TF, both located above the geometric centroid, measured compressive strains and sensors LGS1BF, LGS2BF and LGS2MID measured tensile strains.

A comparison of the curves also shows that, as expected, the further a sensor is from the geometric centroid of the cross section, the greater the strain it experiences. Additionally, sensors positioned at the mid-span of the beam experienced higher strain levels than those located at Section S1, which is nearer to the support.

More specifically, the maximum recorded compressive strain at Section S2 was 590 $\mu\epsilon$, while the maximum tensile strain reached 502 $\mu\epsilon$. Sensor LGS2MID, located closer to the geometric centroid recorded a maximum strain of 277 $\mu\epsilon$. LGS2BF recorded a strain 1.81 times greater than that of LGS2MID.

Figure 8. Strain curves for the long-gauge fiber optic sensors installed at S2.

In contrast, the FOS located at Section S1 recorded significantly lower strain values, with a maximum compressive strain of 269 $\mu\epsilon$ and a maximum tensile strain of 155 $\mu\epsilon$. This notable difference highlights the effect of the bending moment distribution along the beam. Since Section S2 is in the segment of the beam where the bending moment is at its maximum, higher strain values are expected and observed. Conversely, Section S1, being nearer to the supports where the bending moment is lower, experiences lower strain levels.

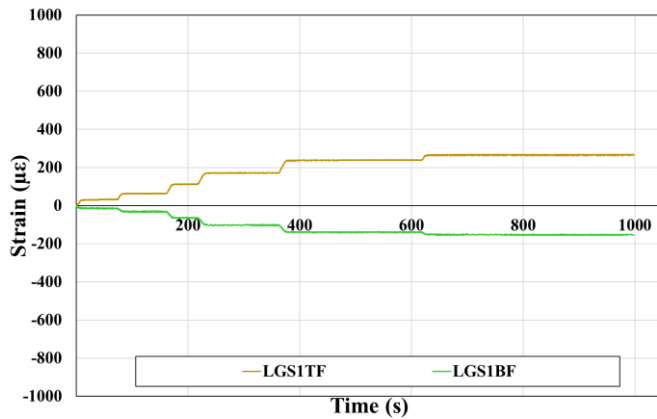
Figure 9. Strain curves for the long-gauge fiber optic sensors installed at S1.

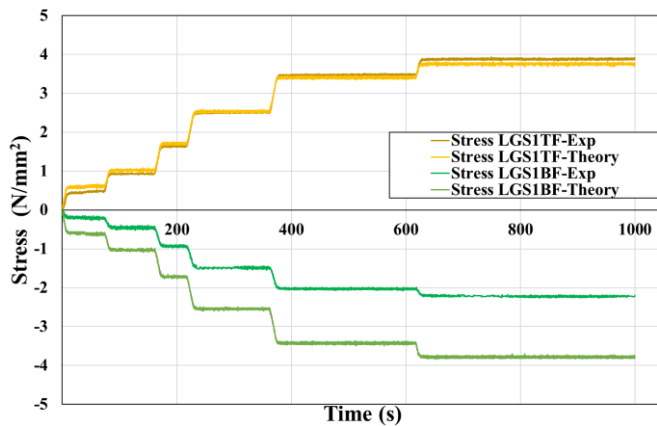
Experimental stresses calculated for section S1 were compared to their theoretical values, as shown in Figure 10. The difference between the experimental and theoretical value for LGS1TF accounts for 0.10 MPa, which is negligible. However, the difference for LGS1BF is 1.59 MPa. More specifically, theoretical calculations provided greater values of tension, but lower compression stress than those obtained from the monitored strains. The maximum theoretical stress values are 3.83 MPa (at the location of the top sensor) and 3.85 MPa (at the location of the bottom sensor), which suggest the exact same stress at the tensioned fibers and at the compressed fibers, and it is justified by the 0.31 mm difference at the installation position in relation to their respective extreme face (top face or bottom face of the beam). However, experimental results of maximum stresses for LGS1TF and LGS1BF locations are 3.93 MPa and 2.26 MPa respectively. These values denote a clear dominance of compression over tension along the length where the sensors are installed for section S1.

At this point it is worth noting that the calculations assumed several hypothesis. Stress calculated with Equation 1 assumes that the material is homogeneous and linear elastic. As it is known for timber, this constitutes a simplification, since it is a heterogeneous material, with varying properties in each direction. Local defects, such as the presence of knots, where the density of the timber grain is higher, and some variability in the direction of the timber fibers can also influence the behavior of the beam under loading, leading to differences between the compression and the tension stresses. Minor differences in the installation of the sensors to the beam can also lead to differences in the results, such as the distance from sensor LGS2TF's axis to the top face of the beam, which is 27.88 mm, while for LGS2BF is 23.54 mm. Accuracy during

Figure 10. Theoretical stress versus experimental stresses at section S1.

- FOS have the potential to detect localized anomalies in material behavior. For example, sensor LGS1TF-Exp exhibited a 58.7% deviation from its theoretically derived stress value, a difference which cannot be overlooked. Possible explanations include the presence of defects—such as knots or abrupt grain deviations—that alter local strain behavior. Installation-related issues may also have contributed to the anomaly.

- Further research is needed to systematically explore the causes of large deviations between measured and theoretical stress values. The nearly 59% error observed at the location of sensor LG-S1-BF is too large to be attributed solely to timber's natural variability—such as knots, fiber misalignment, or moisture content—though these factors do influence strain-stress correlation. It is therefore likely that some form of installation or operational error occurred. Future work should include defect mapping, and improved sensor validation protocols to try to isolate and quantify these effects.
