Chambon Dam Reinforcement Works

Olivier Chulliat¹, Etienne Grimal², Emmanuel Robbe³

1, 2, 3 – EDF – Hydro Engineering Center – Savoie Technolac – 73373 Le Bourget du Lac – France

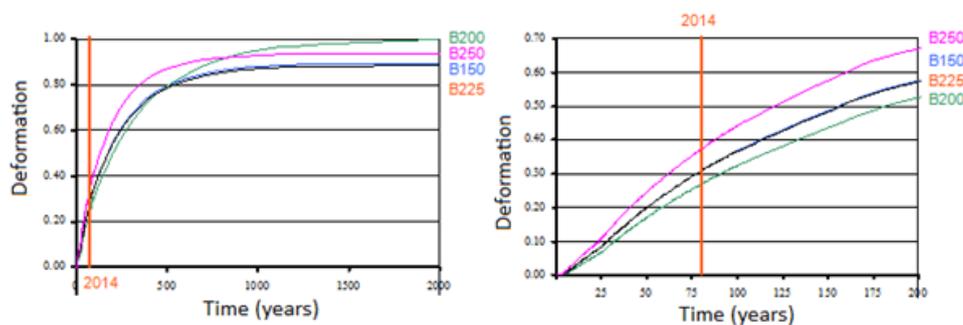
Figure 3. The predicted swelling in the future at Chambon dam

The swelling laboratory tests showed that the expansion of concrete should continue with a relatively constant rate for several decades, even if a gradual slowing is not excluded (Figure 3).

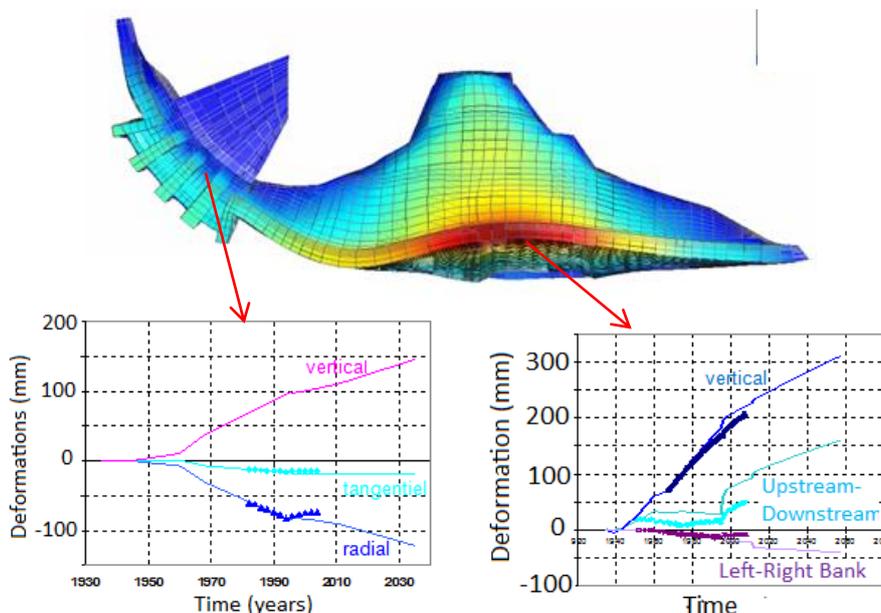
Figure 4. Comparison of measured and computed deformations in 3D modeling

with the monitored dam behavior (Figure 4). The FEM calculations showed that the benefits of the slot cuts done in the 1990's still remained in the upper part of the structure, confirmed by the monitoring of the deformations in the curved left wing.
